# Manhole Inspection Summary

## Manhole # S15II1019MH

**Location** Address: **4250 GREENSPRING AVE**

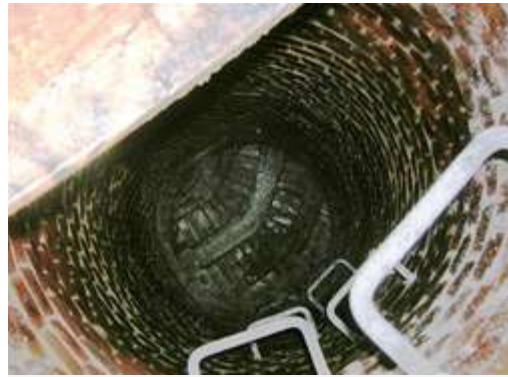
Top View

Corroded steps. Evidence of surcharge - Bench debris.

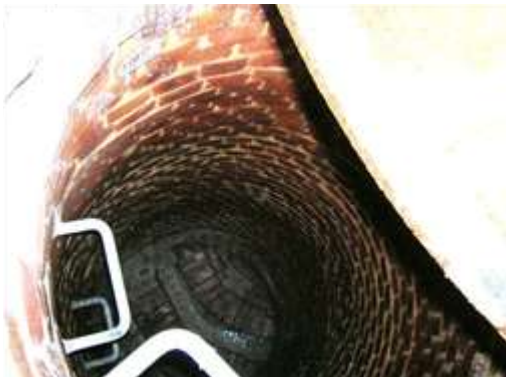
Defect

Condition: ☐ Sound ☐ Cracked ☐ Root Intrusion ☒ **Loose Brick** ☒ **Deteriorated**

Infiltration: ☐ None ☒ **Joint** ☐ Cracks ☒ **Mortar** ☐ Roots ☐ Wall

Adjustment infiltration.

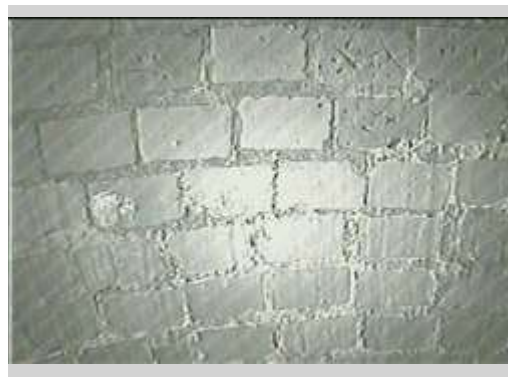
Defect

Condition: ☐ Sound ☐ Cracked ☐ Root Intrusion ☐ Loose Brick ☒ **Deteriorated**

Infiltration: ☐ None ☐ Joint ☐ Cracks ☒ **Mortar** ☐ Roots ☐ Wall

Barrel infiltration.

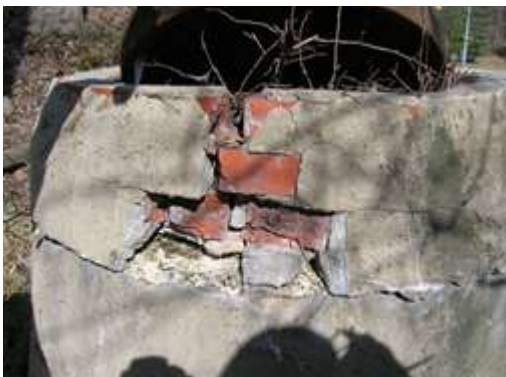
Defect

Outside - Adjustment deterioration and loose brick. - Probable source of infiltration.

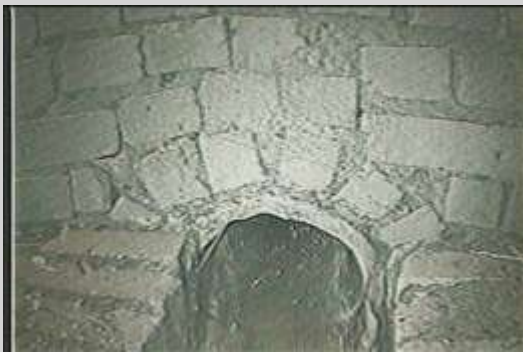
### 8 in. Circular Gravity Sewer Pipe Out @ 12 O'Clock

Deposits: ☐ None ☐ Mud ☐ Sludge ☐ Debris ☒ **Grease**

Infiltration: **None** Pipe Seal Cond: **Roots**

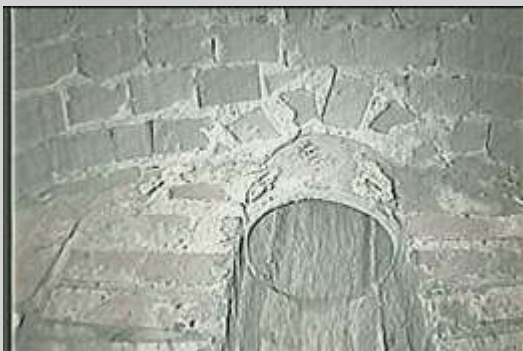
### 8 in. Circular Gravity Sewer Pipe In @ 8 O'Clock

Barrel deterioration and infiltration.

Deposits: ☐ None ☐ Mud ☐ Sludge ☐ Debris ☒ **Grease**
